Safety Notice

Mar-2021

SN2021-004

ZP2 Ziton panel firmware v3.7.10

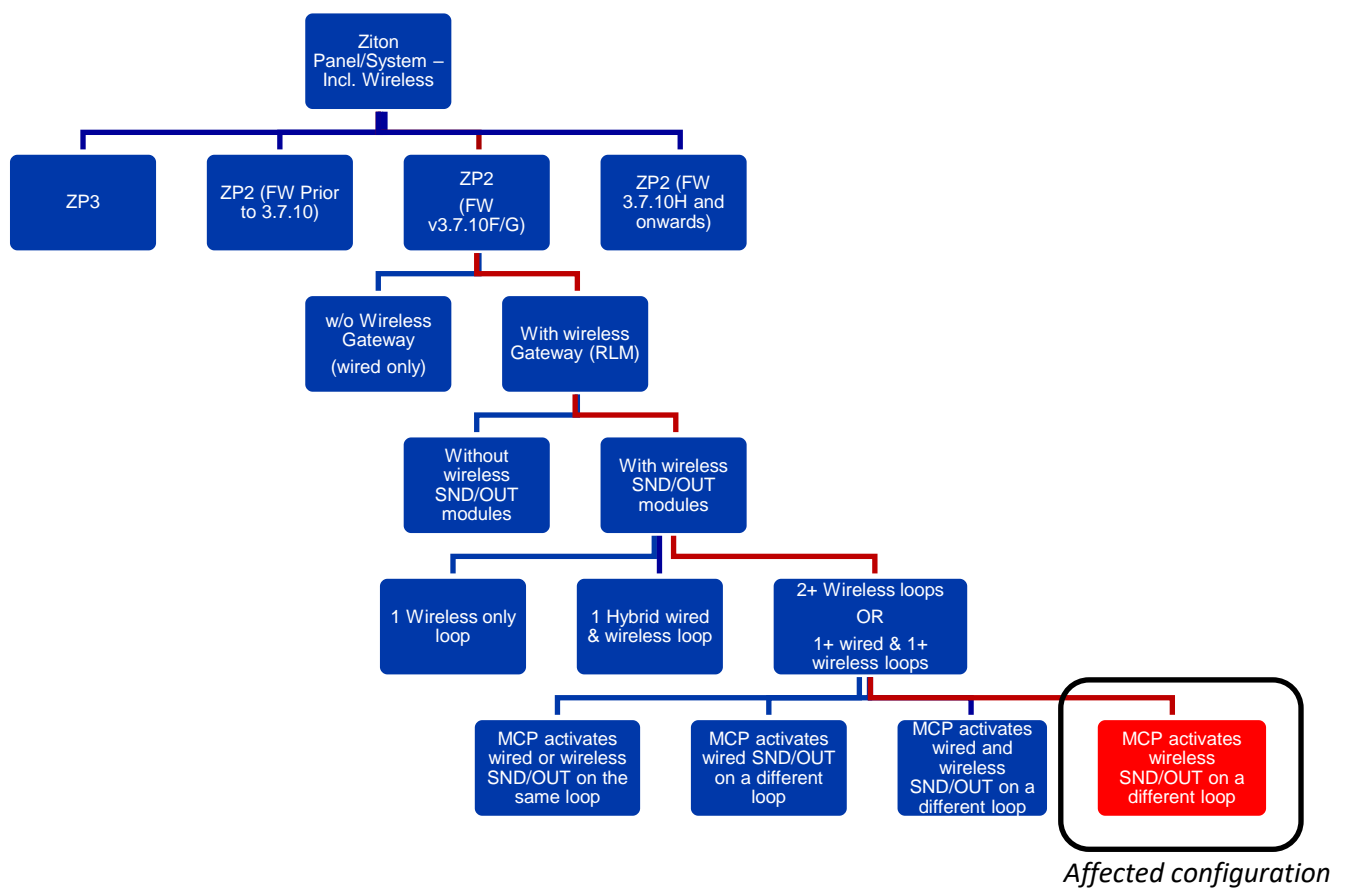
Appendix 1: To identify Potential Affected System Configuration in combination with - Wireless Notification and Output Module Products

This particular issue is applicable only to end user applications with ZP2 control panel (with more than one loop) having firmware versions 3.7.10F/G in combination with wireless notification and wireless output module products (Refer Table 1) connected via RLM/HUB (Radio Loop Modules). Refer to Appendix 1 to identify Potentially Affected System Configuration.

When a MCP (Manual Call Point) is activated in the above configuration, there is a potential panel lock up for 90 seconds. The panel does notify the MCP alarm (alarm LED and alarm message) but the user interface does not respond, nor do the wireless notification and wireless output modules activate during this lock up time. After 90 seconds, the wireless notification and wireless output modules activate, and the user interface is operative again.

This issue occurs under the above conditions, therefore the issue can be detected during installation, commissioning and maintenance when testing all devices. Note, if the panel enters into alarm via a detector, the wireless notification and wireless output modules are activated, and the user interface responds normally.

To remedy these potential issues the ZP2 control panel firmware has been updated to version 3.7.23B.

If within the affected configuration, perform the mandatory upgrade to the latest firmware v3.7.23B as soon as possible.

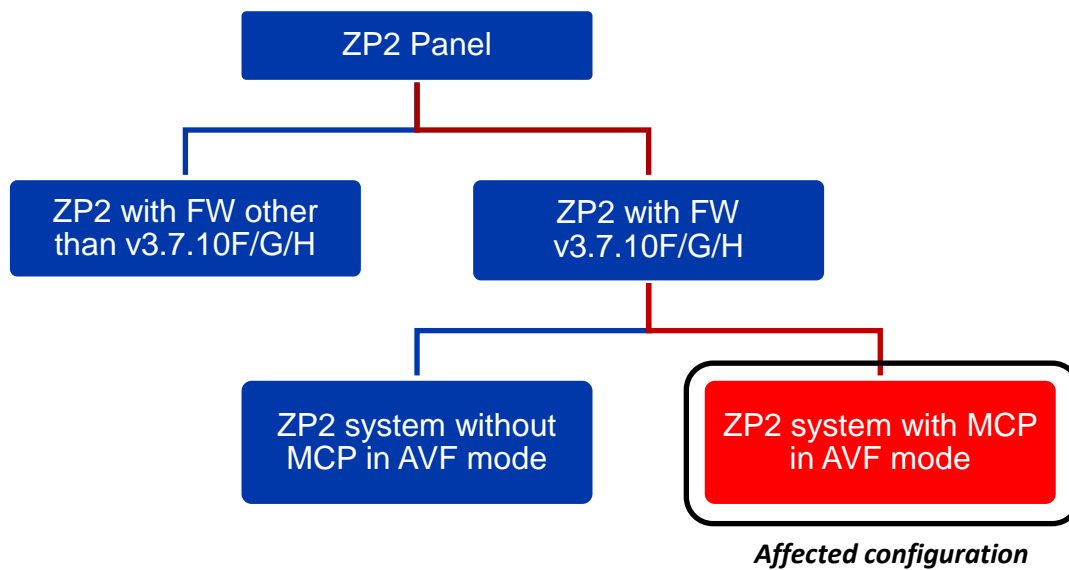
Appendix 2: To identify Potential Affected System Configuration in combination with
– MCP's in AVF mode

This particular issue is applicable only to end user applications with ZP2 control panel having firmware versions 3.7.10F/G/H in combination with MCP's (Refer Table 2) that have been configured in AVF mode. Refer to Appendix 2 to identify Potentially Affected System Configuration.

When a MCP is activated in the above configuration, the panel detects a system fault and is rebooted. After panel reboot (5-6 minutes), the alarm is reported properly if the MCP is still activated.

Note, AVF mode (Auto Verification also known as Alarm Verification) is used for detectors only and is not applicable for MCP's.

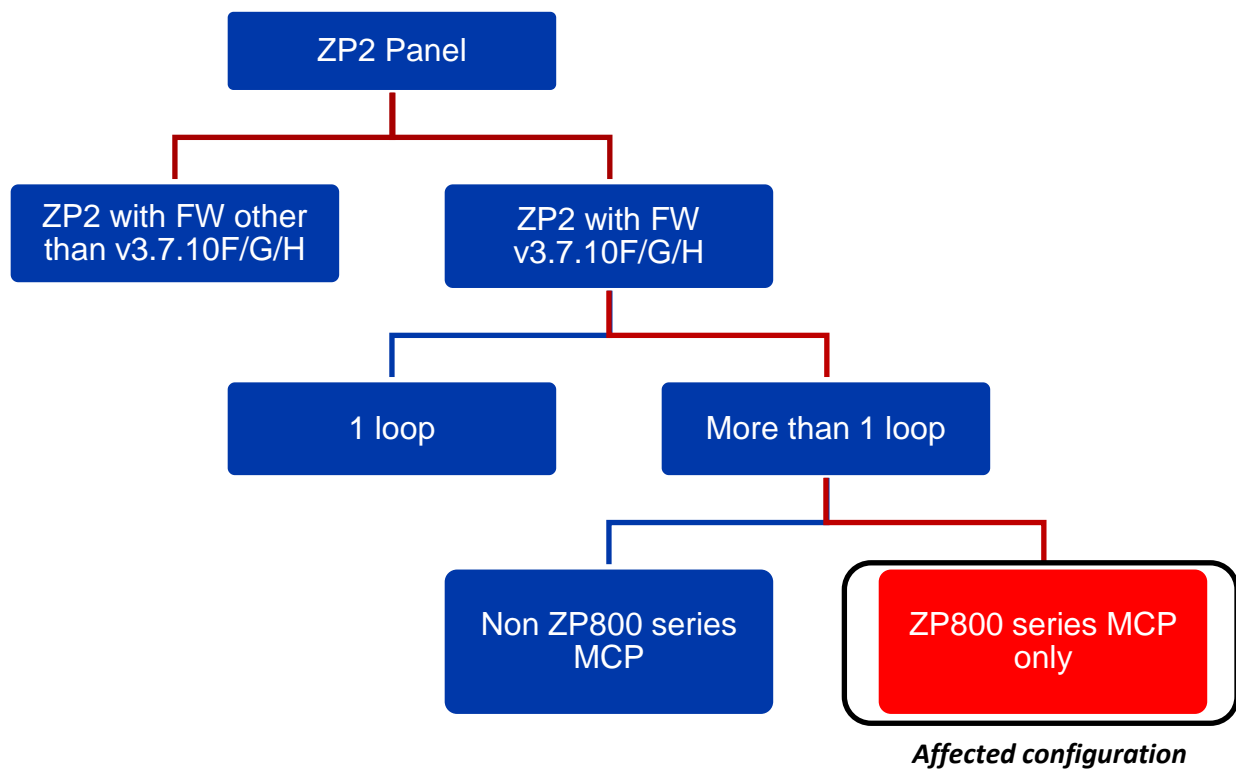
Appendix 3: To identify Potential Affected System Configuration in combination with
– ZP800 series MCP's

This particular issue is applicable only to end user applications with ZP2 control panel (with more than 1 loop) having firmware versions 3.7.10F/G/H and if the positive line in a loop has a short to earth/ground (correctly indicated in the panel as a ground fault). Refer to Appendix 3 to identify Potentially Affected System Configuration.

When a ZP800 series MCP (Refer Table 3) is activated in the above, the panel UI freezes (3 minutes) and then reboots (5-6 minutes) delaying the notification of the alarm a total of 8-9 minutes.

If an alarm notification is in progress, the notification will stop during 8-9 minutes and will continue after this time.
